MTL TR 89-90

# FAILURE ANALYSIS OF A MISSILE LOCKING HOOK FROM THE F-14 JET

VICTOR K. CHAMPAGNE, Jr. and GARY WECHSLER  
MATERIALS TESTING AND EVALUATION BRANCH

September 1989

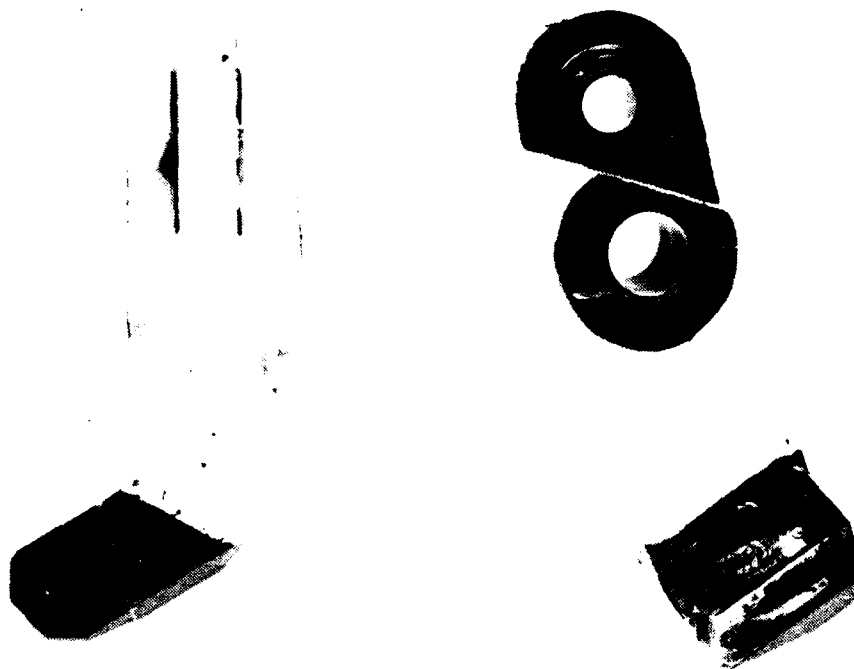
The missile hook (Figure 1a) is located on the F-14 jet and is part of the Lau 92 Ejection Launcher System. The component is one of two launcher housing support points for the Sparrow Missile, as shown in Figure 1b.

Figure 1a. Reduced photographs revealing two views of the missile hook.

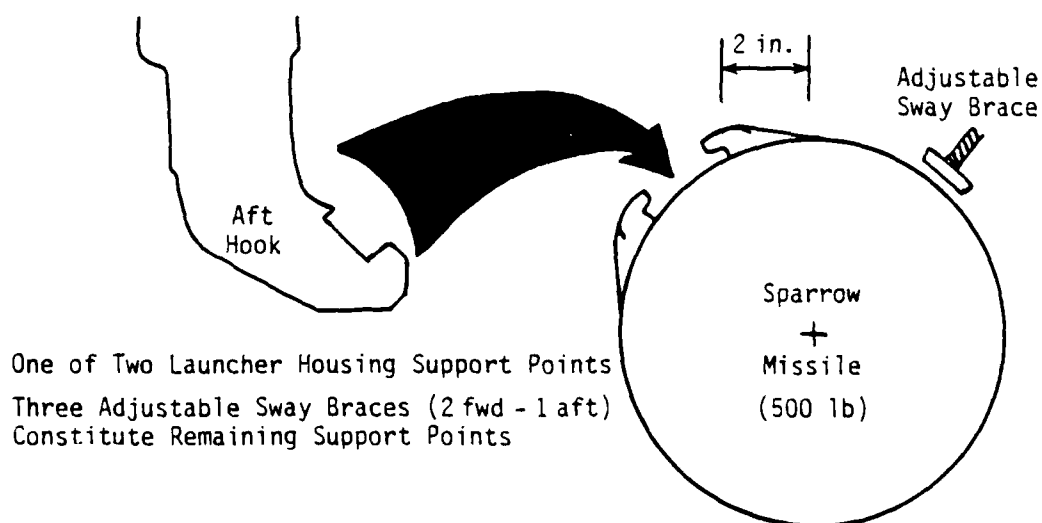
The hook is inserted into a mating component, located on the 500 lb Sparrow Missile (Figure 1b) providing support and stability. The contact areas between these parts are subjected to vibration and shock loading during all phases of flight, especially while landing the aircraft. This repeated motion caused mechanical wear at the interface.

Figure 1b. Schematic illustrating the locations of the support points on the Sparrow Missile.

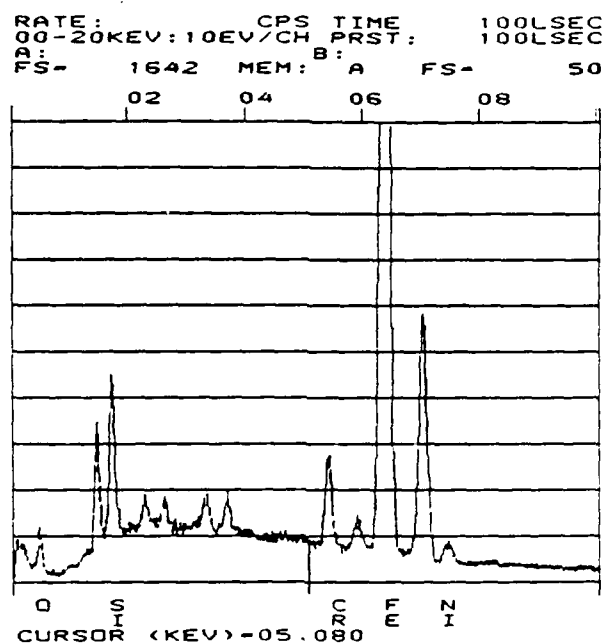
Energy dispersing spectroscopy (EDS) of the dark material produced spectra that contained those elements associated with the type of steel under investigation as well as oxygen (see Figures 17a and 17b). The black layer was concluded to have been a corrosion product, and not contaminants. The formation of this oxide layer was later attributed as having occurred during the slow propagation of a service-related fatigue crack. Figure 15 shows a series of fine progression marks, or beach marks, barely visible within Zone 1. These macroscopic features reveal successive positions of an advancing crack front and are associated with fatigue-fracture surfaces. Under microscopic examination, fatigue striations were observed within Zone 1. Striations often occur in fatigue fractures and are the result of a single cycle of loading. Figure 18 shows these striations, which extend horizontally across the fractograph. Corrosion products are visible in various locations of the figure. Excessive corrosion can mar the fracture surface making it nearly impossible to distinguish microstructural features and interpret topology. The fracture under investigation contained a significant amount of corrosion in Zone 1, which made fractographic observations difficult in that area, but also verified that this region was the result of a preexisting crack which had been exposed to the environment for a period of time.

Figure 17a. EDS spectra of Zone 1 showing the elemental constituents of 300M steel and oxygen.

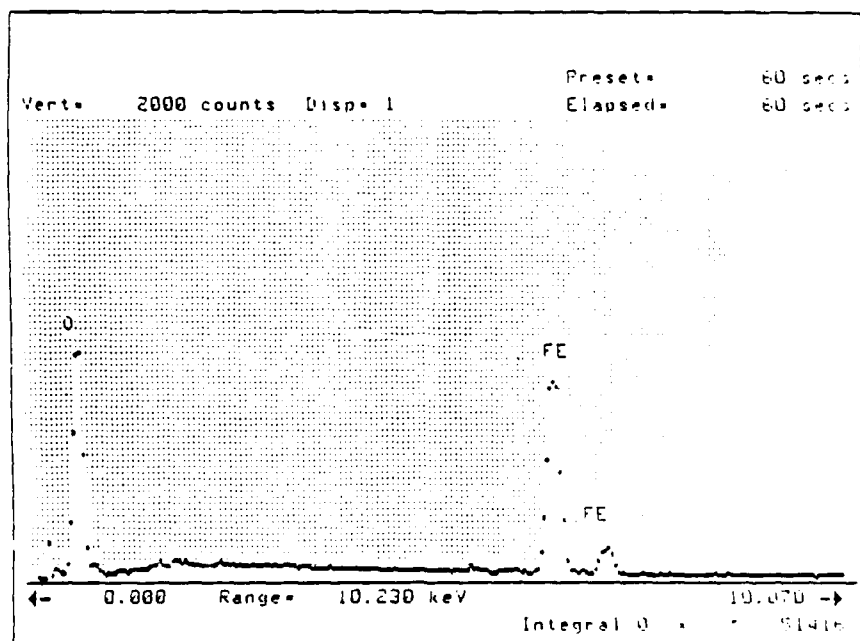
Figure 17b. EDS analysis of another region located in Zone 1 containing large amounts of iron and oxygen.

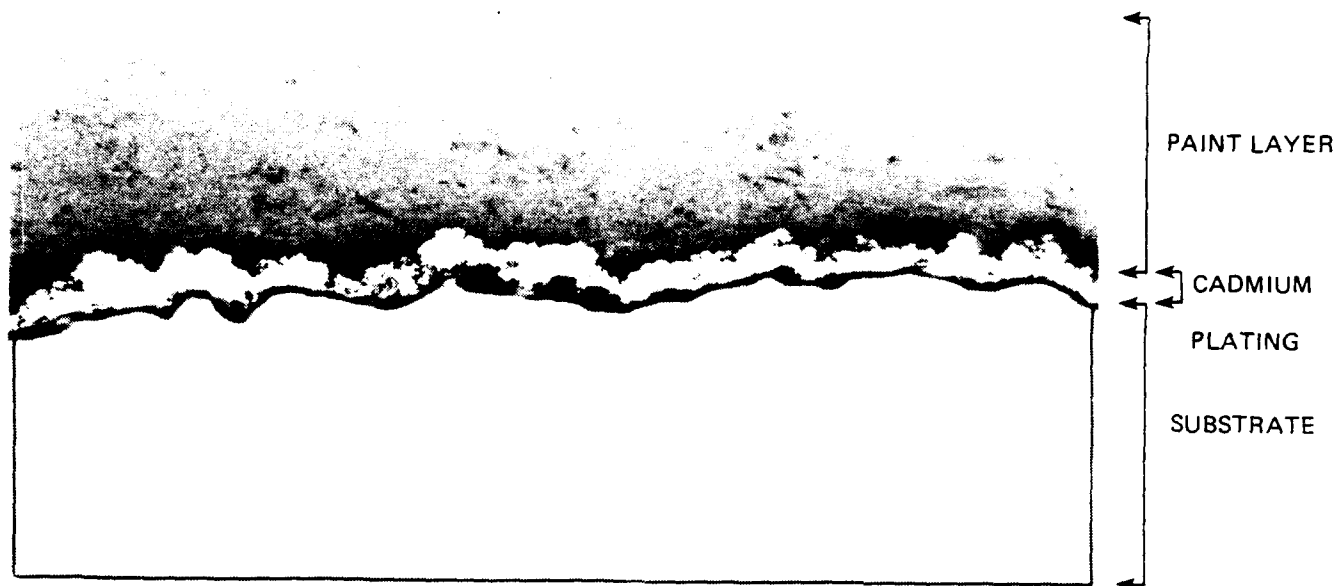
Specimens A and AA were utilized for microscopic examination of the cadmium plating and the paint. Figure 27 is an optical micrograph showing a typical cross-sectional view of the coatings. Regions of the cadmium layer were measured and found to have a thickness range of approximately 0.0003 to 0.0006 inches. These readings conformed to the requirements set forth in MIL-C-8837, Section 3.4.1, which stated that the thickness of the cadmium plating shall be 0.0003 inches, minimum. Figure 28 is a SEM micrograph also containing both coatings. The cadmium plating and the paint layer have been designated on the figure as Area 1 and Area 2, respectively. Further examination of these regions under high magnification revealed no significant signs of faulty adhesion, blistering, peeling, or misplating.

Figure 27. Optical micrograph of the cadmium plating and the paint, Mag. 500X.

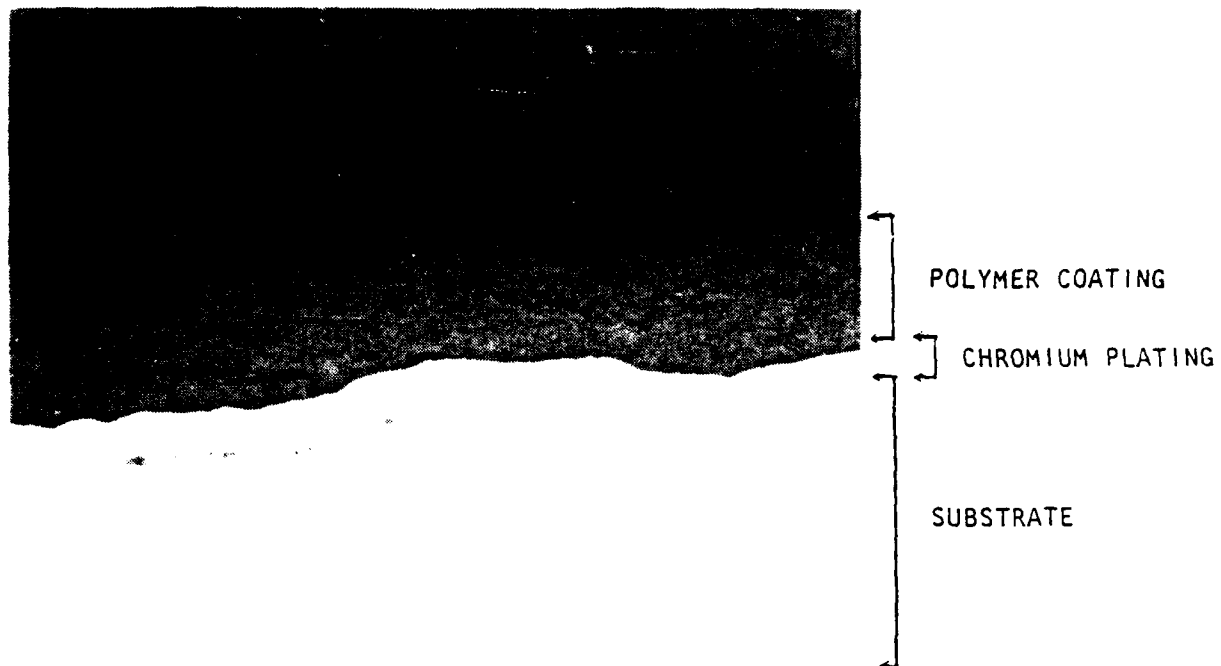
Specimens B and BB were retained for microscopic examination of the "Microlube" coating. Figure 31 is an optical micrograph of a representative region containing a cross-sectional view of the coating. The chromium-based alloy was identified on the figure as the white layer. This coating was deposited onto the substrate by ion displacement. The dark layer corresponds to the fluorocarbon polymer that was applied by a duplex electroregistration process and used as a friction and corrosion inhibitor. The specimens were etched using Villela's etchant.

Figure 31. Optical micrograph showing the "Microlube" coating composed of distinct chromium and polymer layers, Mag. 500X.

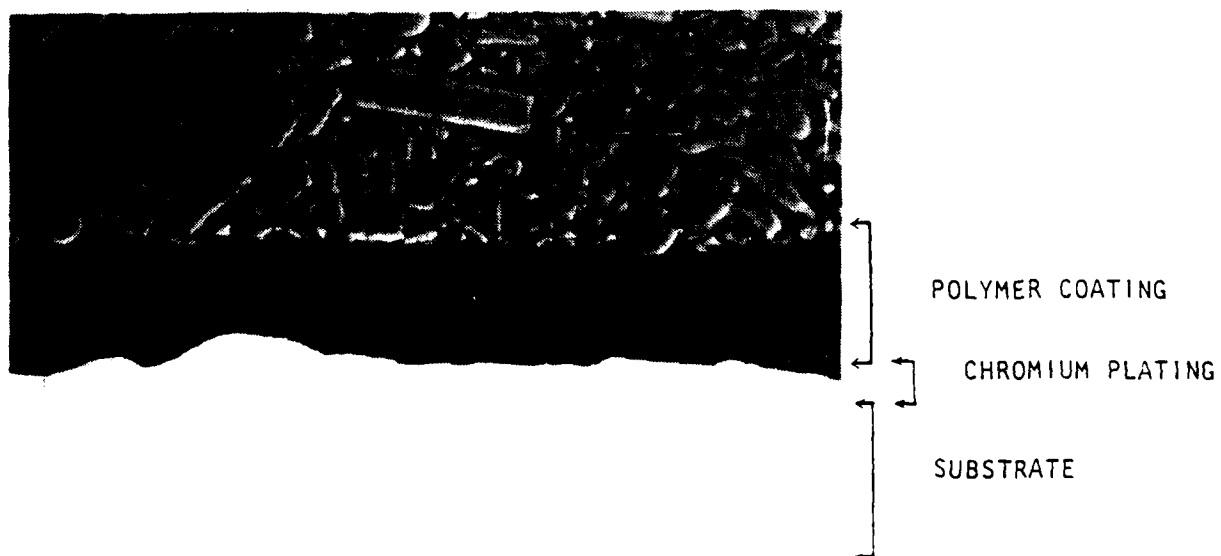
Figure 32 is a SEM micrograph showing the chromium and polymer layers. The engineering drawing for the missile hook, (reference Raytheon Drawing No. 685029, Figure 14), stated that the "Microlube" coating shall have a thickness of 0.0008 to 0.0012 inches. The chromium layer had a measured thickness of approximately 0.0004 to 0.0005 inches, while the polymer coating was approximately 0.0008 to 0.0014 inches thick. The total thickness of the "Microlube" coating was 0.0012 to 0.0019 inches, which exceeded the specification. Maximum thickness requirements are prescribed for coatings to insure proper adherence and coherence.

Figure 32. SEM micrograph of the chromium plating and the polymer layer which constitute the "Microlube" coating, Mag. 500X.

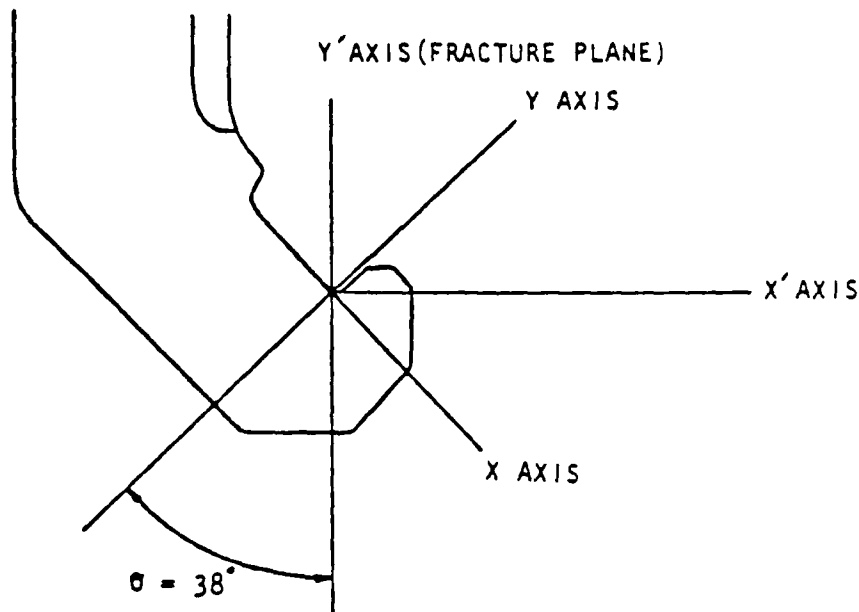
Figure 38. The angle between the fracture plane and the plane about which stresses were calculated.

Since the fracture plane did not coincide with Section A-A, see Figure 38, the stress across the fracture plane must have been greater than that across Section A-A. From this conclusion, the stress across the fracture plane can be approximated,  $\nabla_{x'} \geq \nabla_x$ . Therefore,  $\nabla_{x'} = 154.8$  ksi was used to calculate the critical crack stress intensity factor.
